Strengthening and underpinning of stone foundations of St. John's Church in Gdańsk

M.TOPOLNICKI, Technical University of Gdańsk & Keller Polska Sp. z o.o.

(XV International Conference on Soil Mechanics and Geotechnical Engineering, Istanbul, 27-31.08.2001, Vol.3, p. 1863-1866)

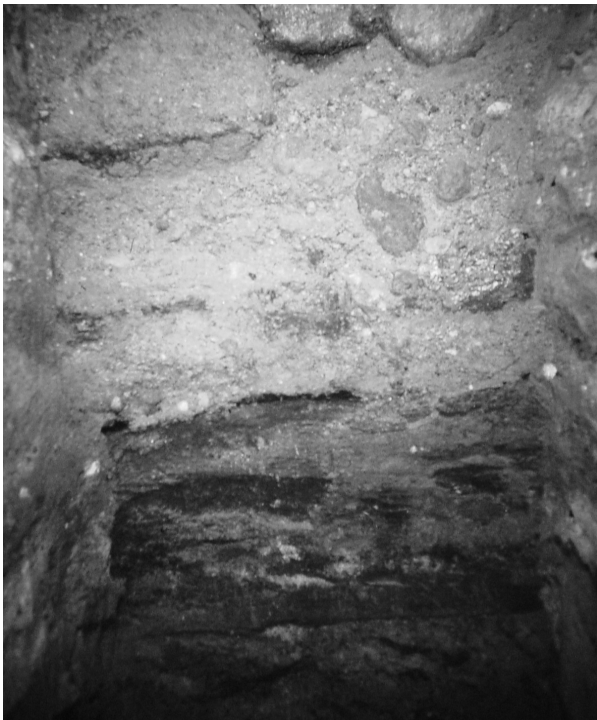
The St. John's church has been founded on a very weak subsoil, containing peat and organic silt layers below a thin fill layer at the surface. Initial foundation works started with excavation of the top layer of soil down to the groundwater level, since dewatering techniques were not available at that time. Gravel, stones and weak mortar were subsequently placed inside wooden formwork, which was pushed into the peat layer. On this support stone foundations for church walls and pillars were constructed. A photograph taken from a recent excavation pit at the south site wall of the church shows wooden beams at the depth of about 4.5 m and overlying stones of the foundation wall (Fig. 3).

Fig. 3 Side view of excavated foundation wall (1995).

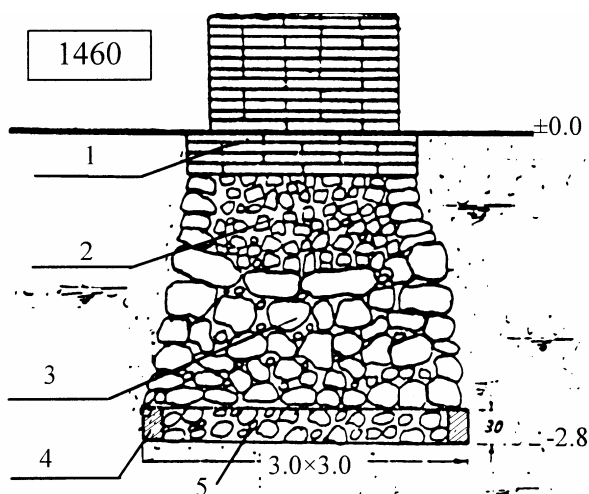
Fig. 4 Initial construction of the foundation under a pillar: 1- bricks and lime mortar, 2- small stones, brick pieces, lime, 3- bigger stones without lime, fill, 4- wooden box, 5- field stones with clay (Bukowski, 1948).

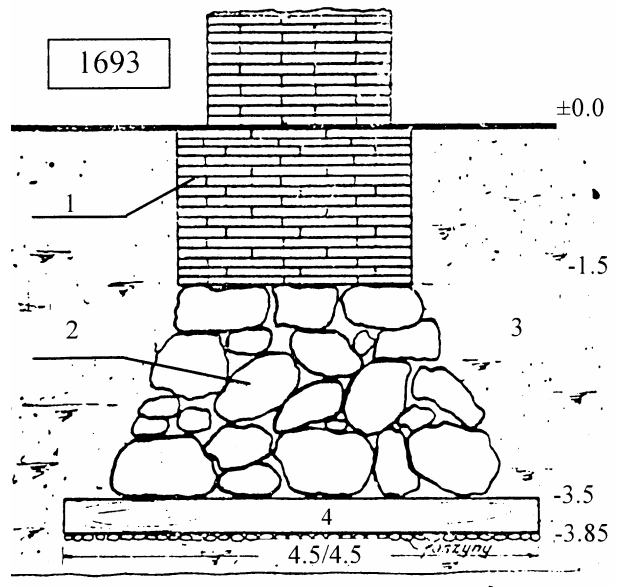
Fig. 5 Rebuilt foundation under a pillar: 1- bricks and lime mortar, 2- large stones and lime mortar, 3- refill (sand and peat), 4 - wooden beams on fascine mattress (Bukowski, 1948).

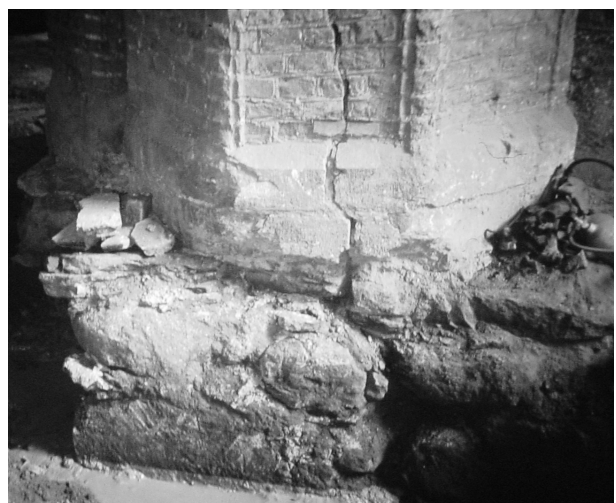
All these difficult and challenging engineering works could not, however, stop further excessive settlements. It has been estimated that total vertical displacements had reached about 75 cm from the beginning of church construction. A particularly difficult situation occurred at the eastern wall behind the altar, which started to tilt. In 1679 the horizontal displacements observed at the vault level reached nearly 100 cm (Bukowski, 1948). The outward movement of this heavy wall, transmitted to two rows of pillars through the vault structural elements, caused also significant displacement of six adjacent pillars. These additionally experienced lateral movements at the floor level in the order of 25 to 50 cm. As a countermeasure two buttresses founded on wooden piles were quickly built at the outer side of this wall and the roof in this part of the church was reconstructed and unloaded. At later dates this church was also burned and damaged, particularly during the second world war, and subsequently partly repaired. Its material condition became however steadily worse and worse (cf. Fig.6).

Fig. 6 Cracked pillar pedestal in the eastern part of the church (1995).

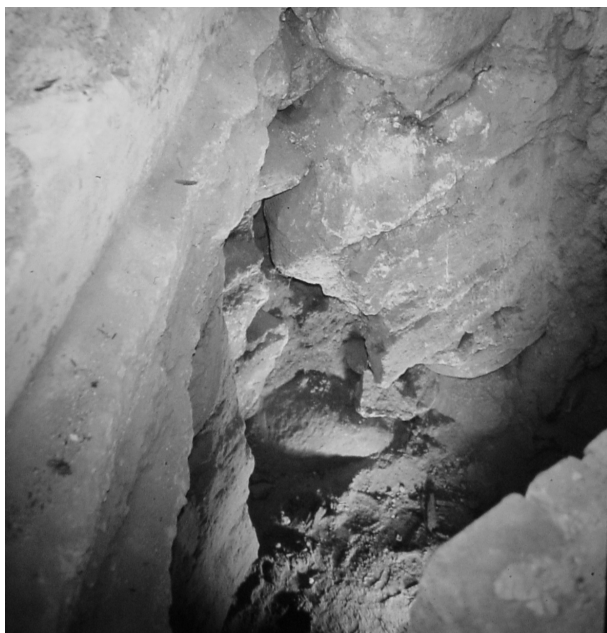
The most difficult works were executed under the pillars, which carry not only high loads but also have experienced vertical and horizontal displacements. Therefore, it was assumed in the design that the remediation should lead to improvement of the bearing capacity in both a vertical and horizontal direction and to internal strengthening of the foundations. The latter became especially important after recognition that some of the foundations had rather wide cracks, extending to a significant depth below the pedestal (Fig. 7).

Fig. 7 Cracked stone foundation of a single pillar

The jet grouting works started with execution of primary soilcrete elements around the expected periphery of the foundation,

determined by old drawings and additional trial borings. The objective was to form a soilcrete "box" around the foundation prior to any attempt to install columns directly under the pillar. These side elements were executed at the bottom part as panels, e.g. in case of pillar C7 between -4 and -7.5 m, and as half columns above the foundation level (Fig. 8). This was achieved by extraction of the drill rod without rotation to create a panel and subsequently by rotating the rod 90° in the upper part. In this way the conical walls of the foundation were surrounded by soilcrete and the loose granular fill was locked in.

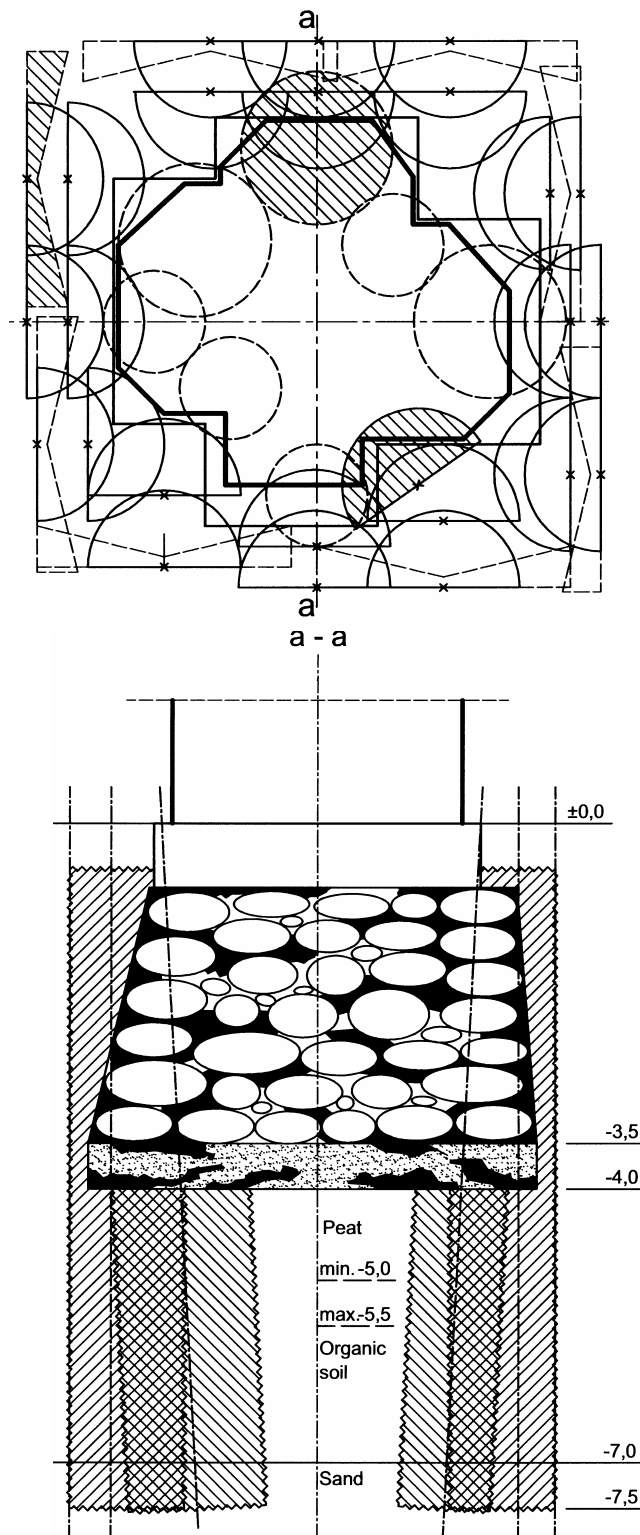
Fig. 8 Layout of soilcrete elements under a pillar C7

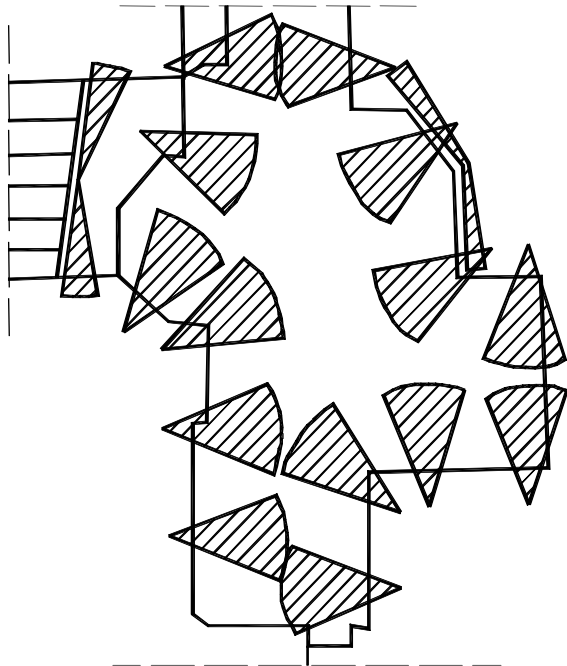
Fig. 9 Layout of soilcrete elements under the eastern wall (detail E, see Fig. 2)

At the second stage inclined core drillings of 150 mm diameter were made through the pedestal and stone foundation. This operation required special equipment and skill of the operator, especially when loose fill was found between the larger stones. Once the drilled wholes were completed cement grout was injected under pressure to fill all possible cracks and voids. Then the secondary soilcrete columns were made. Under the outer walls special sector elements, the so-called wings, were applied from both sides of the wall (Fig. 9). With this advanced technique it was possible to assure sufficient support of the foundation without drilling through the stones. At the west wall the work had to be partly conducted in cellar using special drilling unit (Fig. 10).

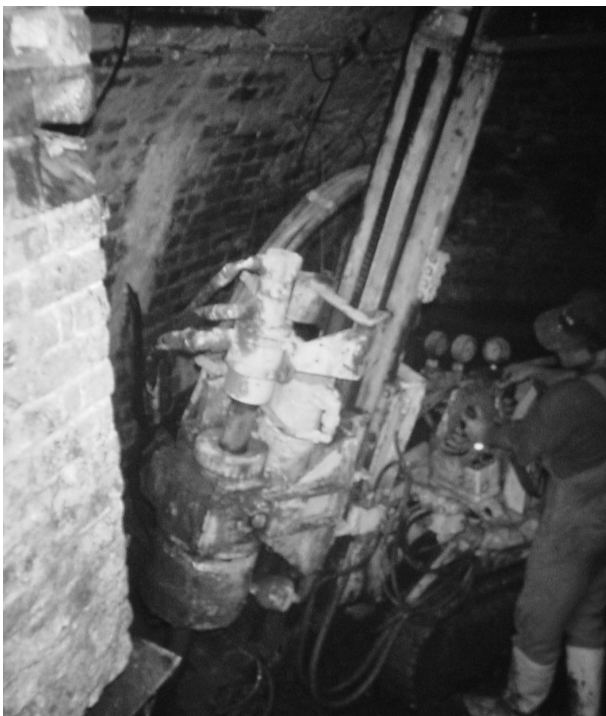
Fig. 10 Soilcrete works in a limited space in cellar

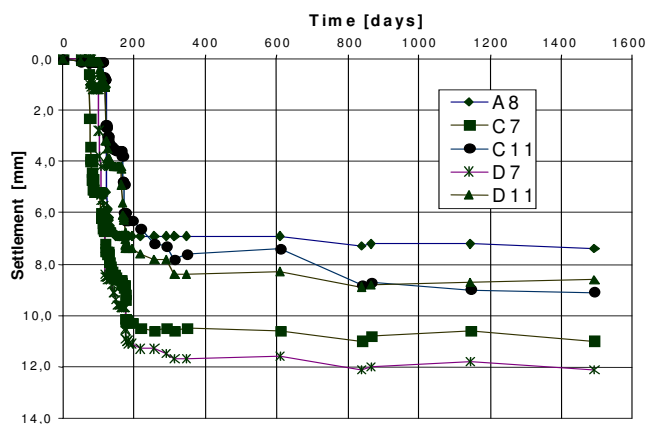
Before, during and after underpinning works precise geodetic measurements were conducted (Żurowski et al). Figure 11 shows sample data obtained during almost 5 years of observation. The selected curves refer to observation points indicated in Fig. 2 and demonstrate the subsequent phases of underpinning works. Execution of soilcrete elements within roughly 150 days induced limited settlement of the foundations, while the settlement rates for secondary soilcrete elements are generally smaller than for the primary ones. The subsequent parts of all settlement records, referring to the state after completion of the underpinning works, indicate fairly stable behaviour of all foundations within the period of almost 3 years.

Fig. 11 Settlement recorded during and after underpinning works at 5 reference points indicated in Fig. 2 (Żurowski et al., 1995-2000)
