Strengthening and underpinning of stone foundations of St. John's Church in Gdańsk

M.TOPOLNICKI, Technical University of Gdańsk & Keller Polska Sp. z o.o.

(XV International Conference on Soil Mechanics and Geotechnical Engineering, Istanbul, 27-31.08.2001, Vol.3, p. 1863-1866)

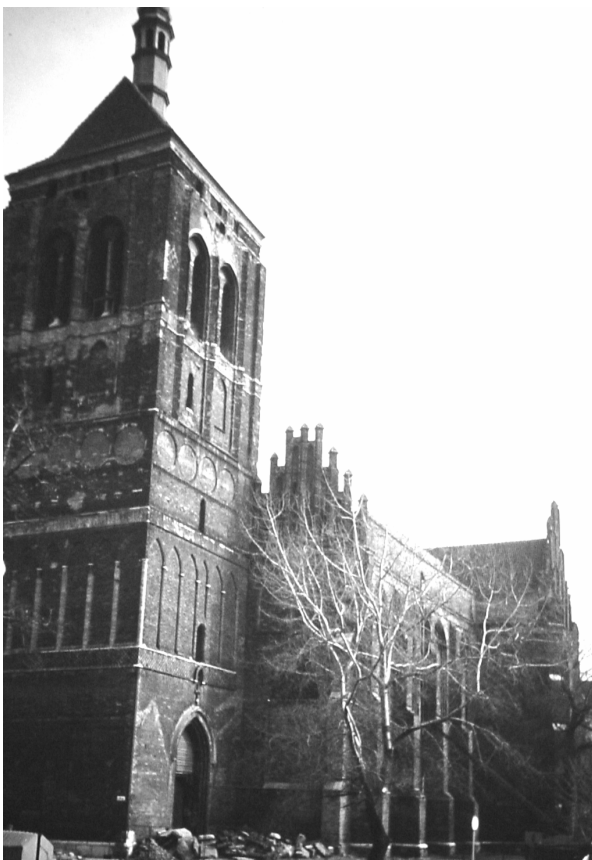
Fig.1 The church of St. John in Gdańsk (1995).

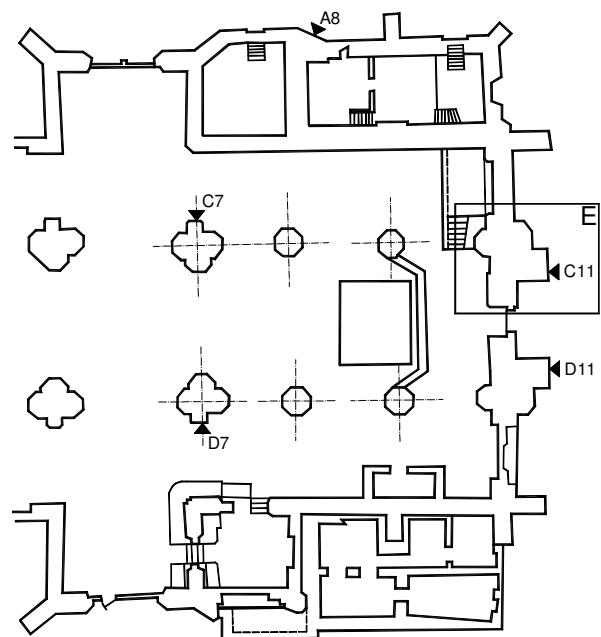
Fig. 2 Layout of the eastern part of the St. John's church.

The jet grouting underpinning works were conducted under 4 smaller pillars close to the altar and two main pillars C7 and D7, as well as under the adjacent outer walls (ref. a sketch in Fig. 2).
